**A METHODOLOGY FOR PRIORITIZING SIGNAL STRUCTURAL ASSEMBLY
REPLACEMENT**

Michael H. Schrader, P.E.
Traffic Control Engineer
Public Works and Development Department
Traffic Operations Division
City of Tulsa
200 Civic Center, Room 633
Tulsa, Oklahoma 74103
(918) 596-9714
FAX (918) 596-9713
e-mail—mschrader@ci.tulsa.ok.us
[Corresponding Author]

City of Tulsa, Oklahoma, Traffic Operations

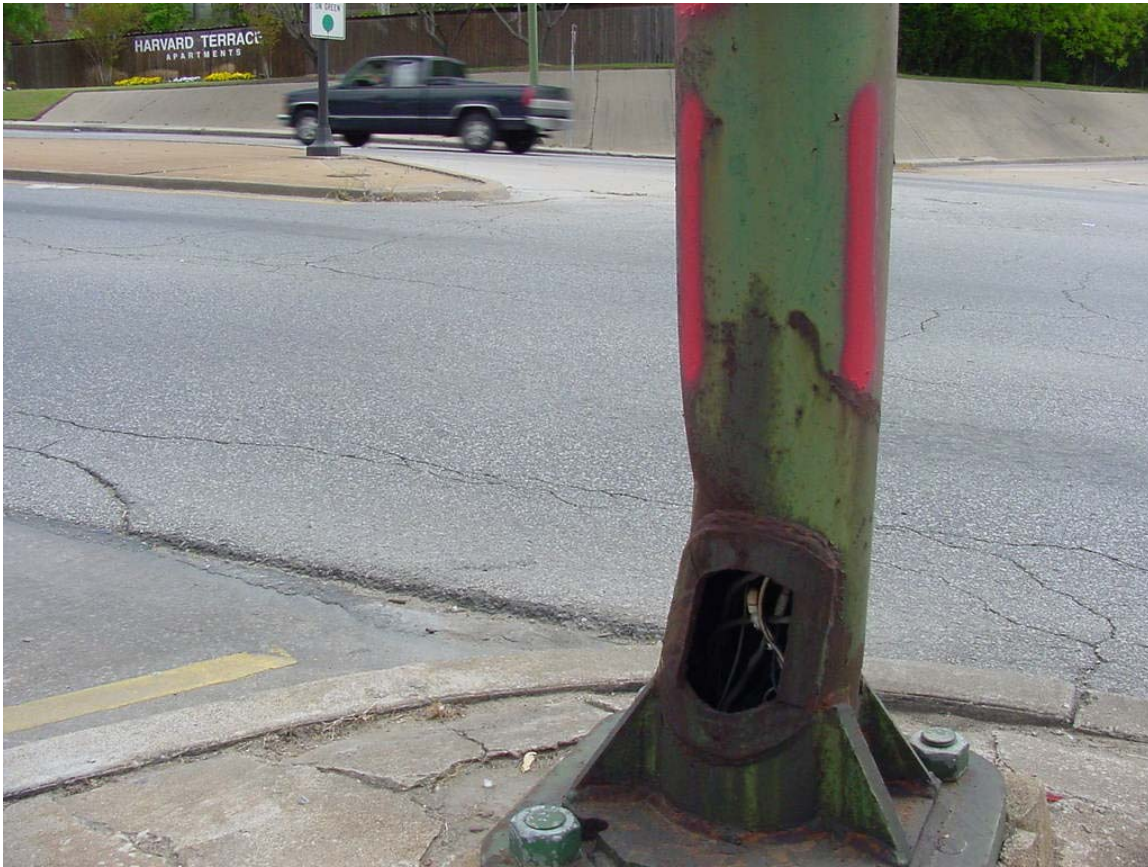
| 7 Pts | Exposure to vehicles |
| 8 Pts | Assembly damaged |

FIGURE 3 Post damaged and in harm's way.

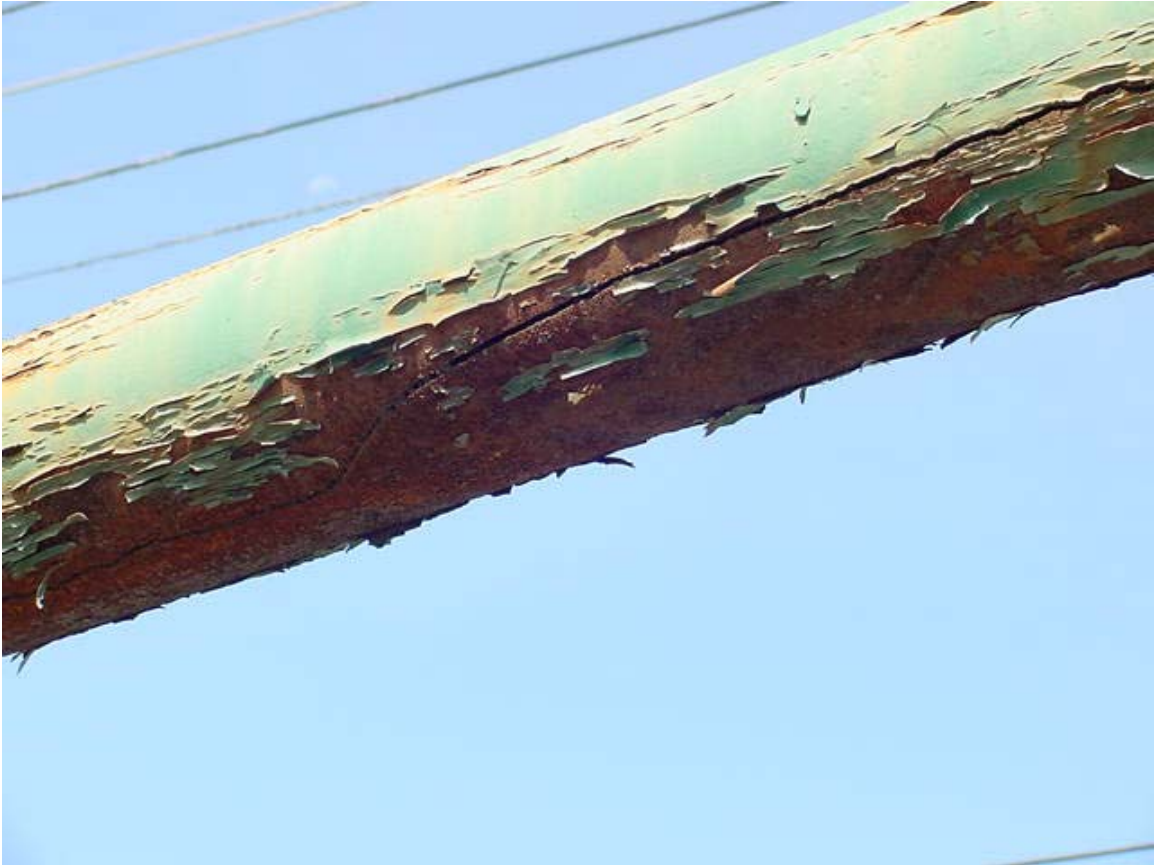
| 13 Pts | Crack in compression arm |

FIGURE 4 Crack in compression arm.

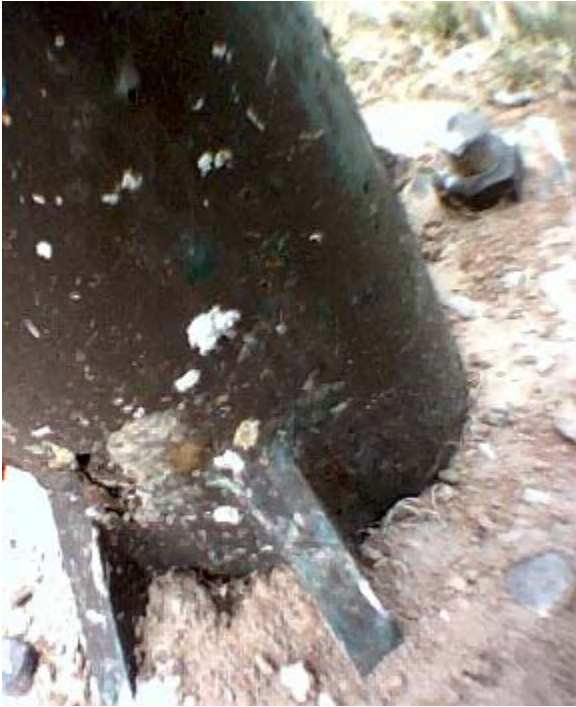
| 18 Pts | Hole above rib flange at base of post |

FIGURE 5 Hole in post above rib flanges.

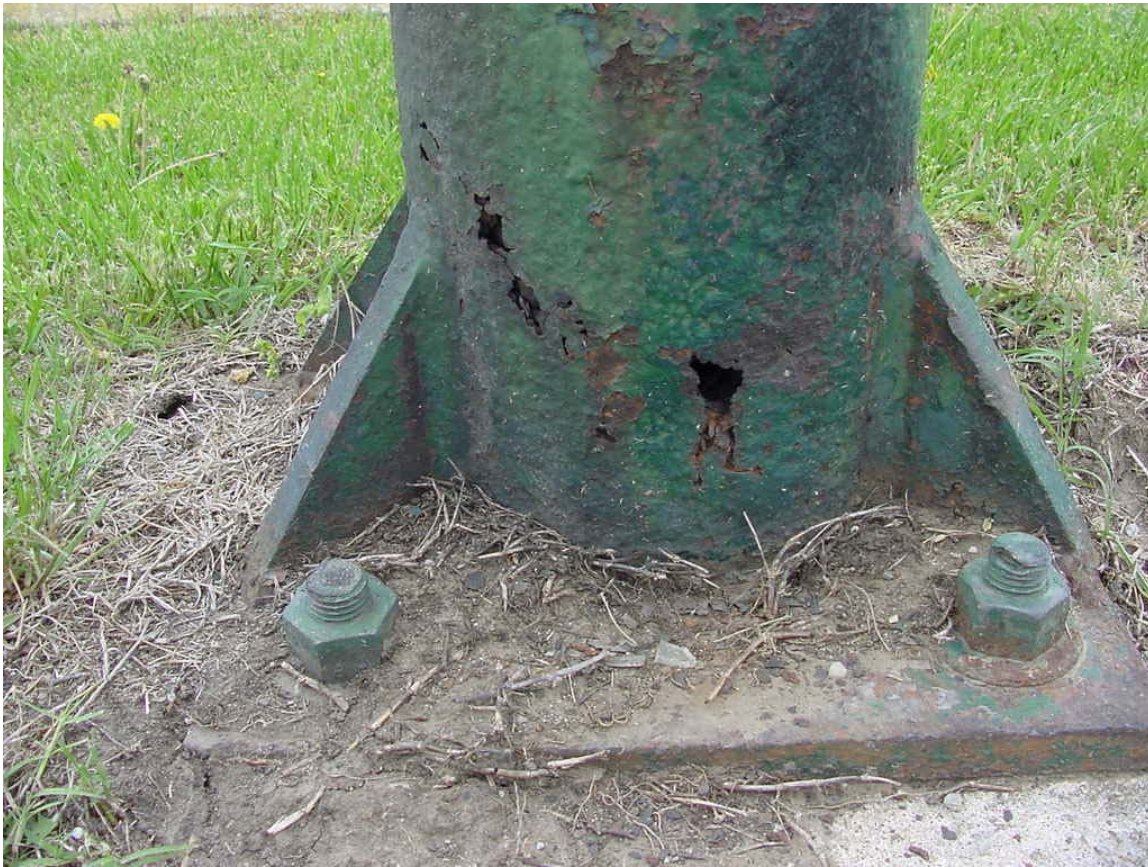
| 17 Pts | Hole below rib flange at base of post |

FIGURE 6 Holes above and below rib flanges.

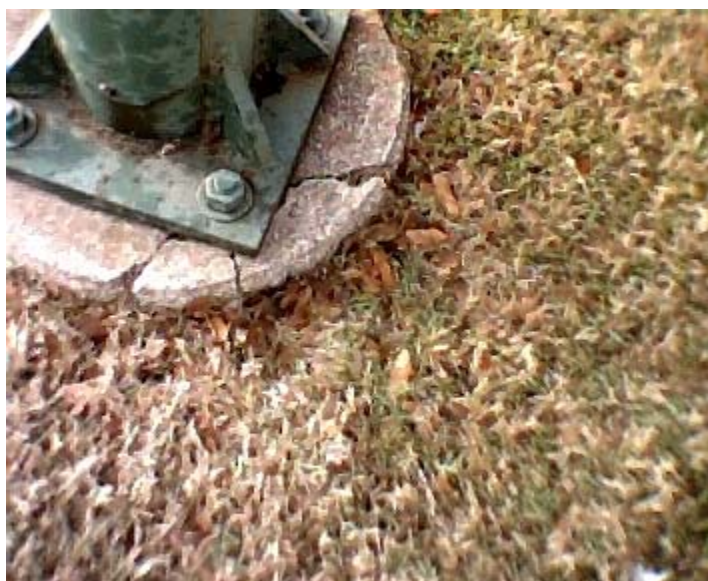
| 21 Pts | Foundation cracked |

FIGURE 7 Cracked foundation.

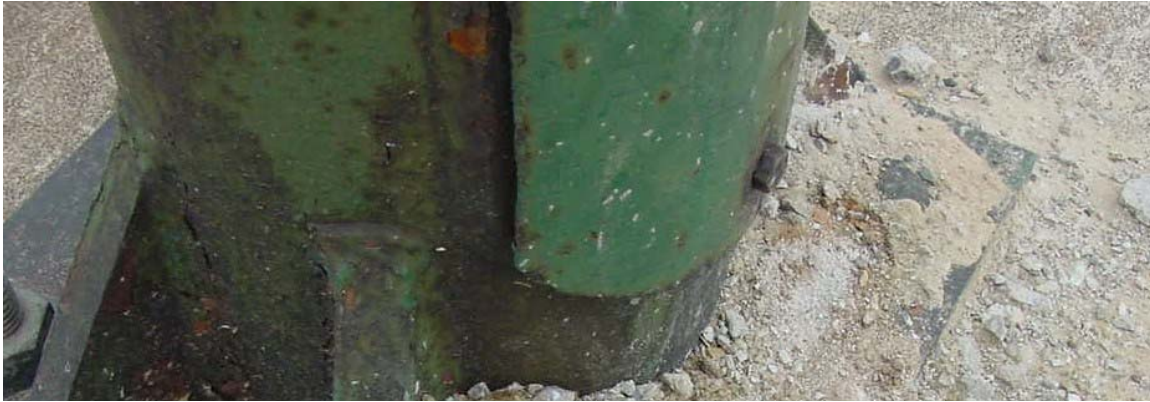
| 22 Pts | Missing or damaged anchor bolts |

FIGURE 8 Missing anchor bolt.
