**A METHODOLOGY FOR PRIORITIZING SIGNAL STRUCTURAL ASSEMBLY
REPLACEMENT**

Michael H. Schrader, P.E.
Traffic Control Engineer
Public Works and Development Department
Traffic Operations Division
City of Tulsa
200 Civic Center, Room 633
Tulsa, Oklahoma 74103
(918) 596-9714
FAX (918) 596-9713
e-mail—mschrader@ci.tulsa.ok.us
[Corresponding Author]

City of Tulsa, Oklahoma, Traffic Operations

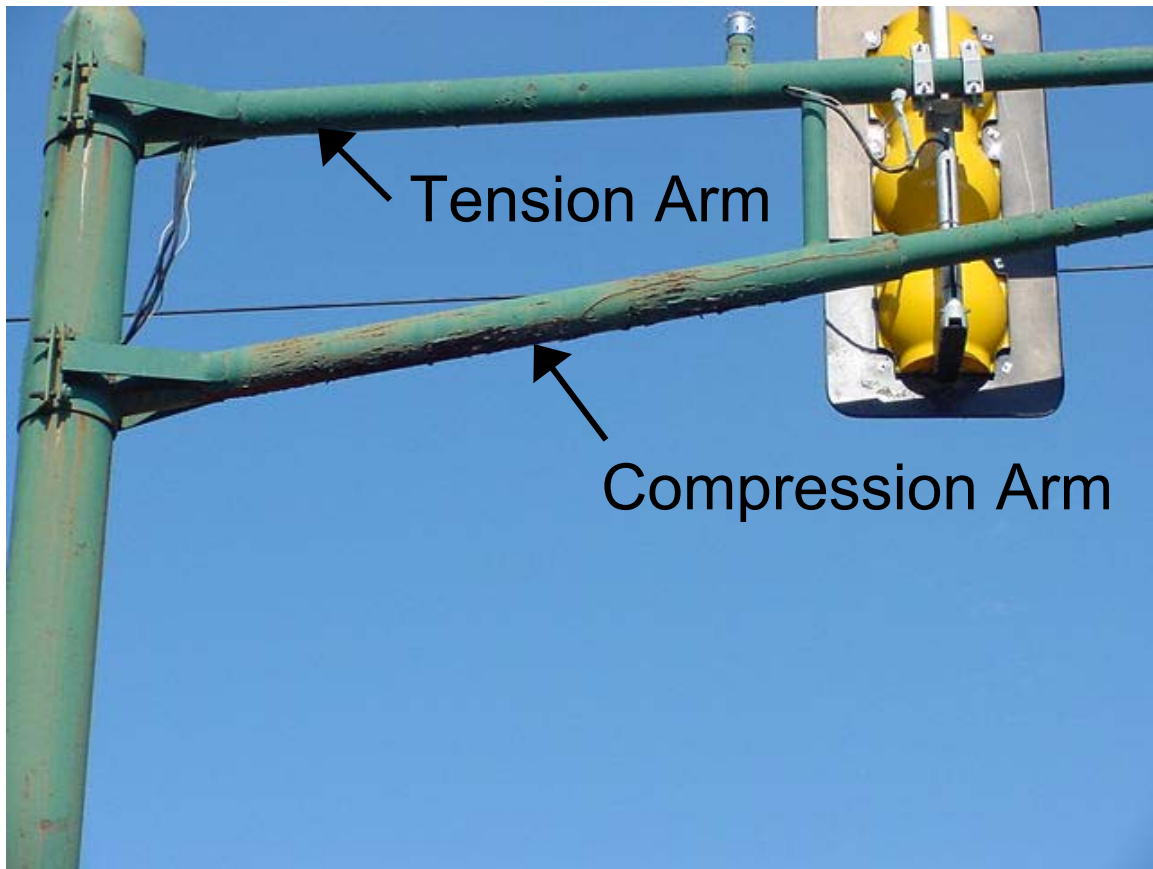
Because of their age, the green arms have two structural elements not typically found on modern, galvanized signal mast arm assemblies. The first of these is a two-arm mast arm configuration. (**Figure 1**) Under this configuration, the lower arm serves as a brace of the upper one, resulting in the lower arm being in compression and the upper arm being in tension under a dead load (i.e. only the weight of the signal heads acting on the arms) condition. Because these two arms are subjected to different forces and stresses, defects in each must be noted individually. In other words, to note that there are holes in the mast arm would not be sufficient to adequately evaluate how much these holes compromise the structural integrity of the assembly, as a hole in the compression arm will impact structural integrity differently than an identical hole in the tension arm.

FIGURE 1 Mast arm nomenclature.

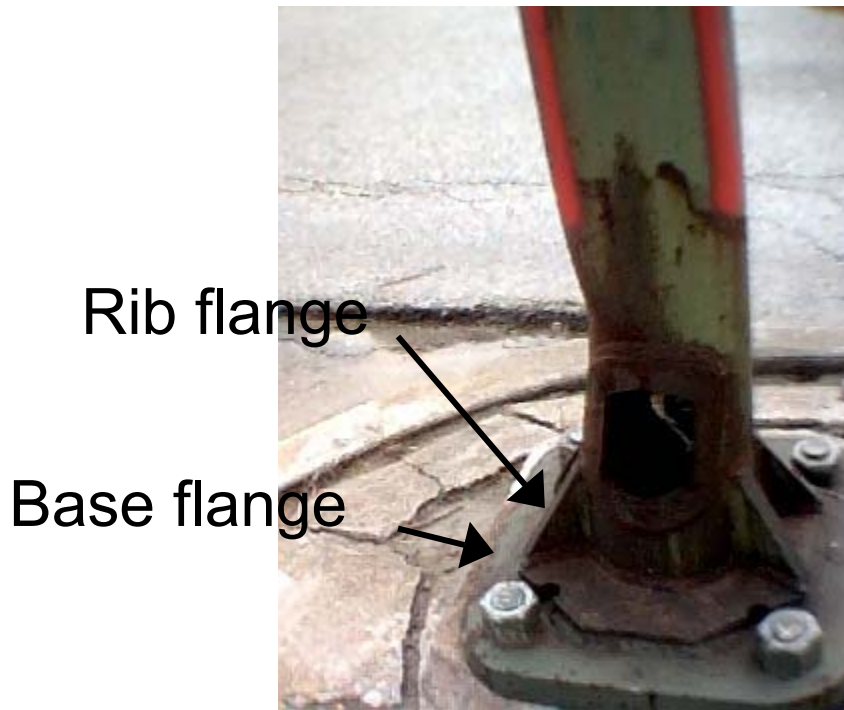
The second atypical structural element is a rib flange at the base of the post. (**Figure 2**) The rib flange is a triangular vertical flange that helps distribute the load from the post into the base flange. Because of these rib flanges, the stresses on any square unit of post surface below the flanges will not be the same as the stresses on an identical square unit of post surface above the flanges. Thus, the need to differentiate between defects to the post located below the rib flanges and defects located above them.

FIGURE 2 Post base nomenclature.
